# PRELIMINARY AIRWORTHINESS EVALUATION (PAE) OF THE OH - 58D HELICOPTER (AHIP)

DECEMBER 1984

FINAL REPORT

UNITED STATES ARMY AVIATION ENGINEERING FLIGHT ACTIVITY  
EDWARDS AIR FORCE BASE, CALIFORNIA 93523

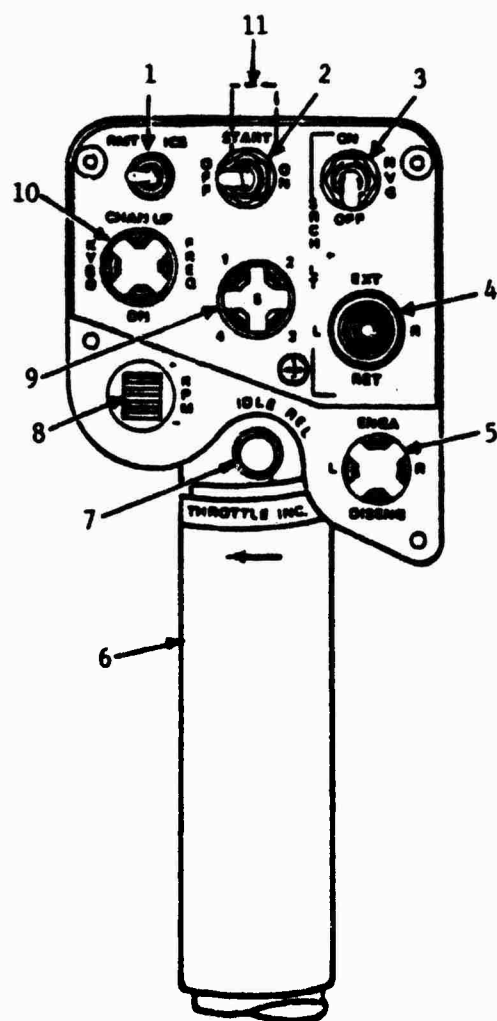
Figure 17. Pilot's Collective Control Head

1. Communication RMT ICS switch
2. START switch
3. Searchlight power switch
4. Searchlight control switch
5. SCAS heading hold ENGAGE/DISENGAGE trim switch
6. Throttle
7. IDLE RELEASE switch
8. RPM trim switch
9. Radio select switch
10. CHANNEL select switch
11. Start switch guard

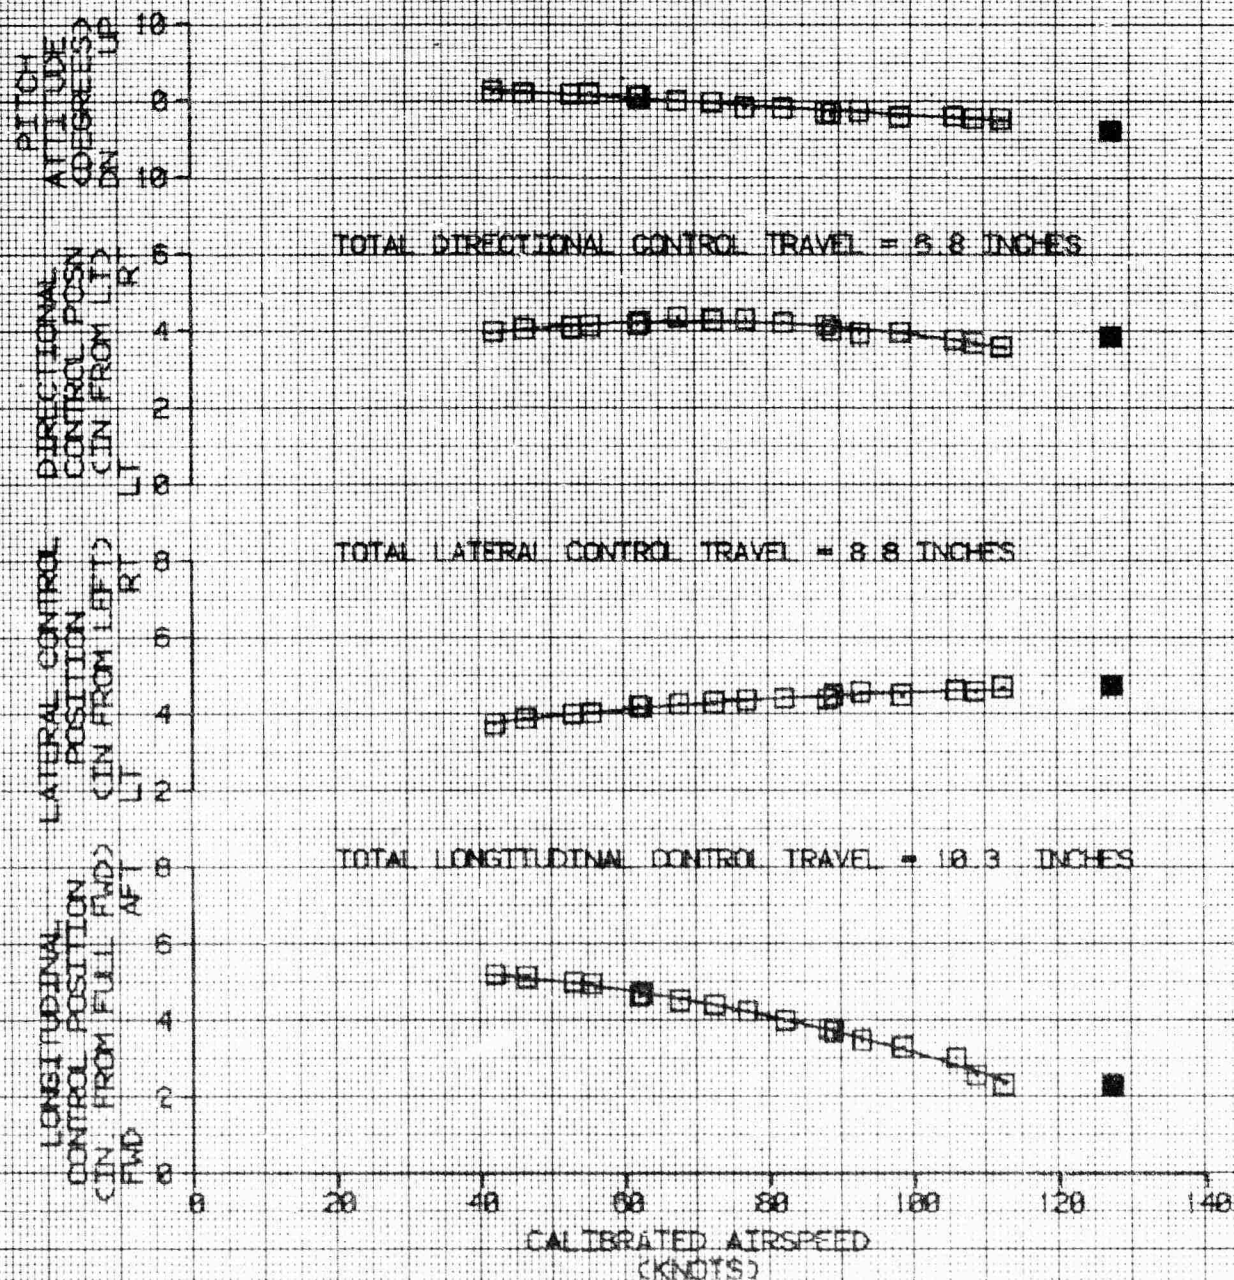
**FIGURE 6**  
**CONTROL POSITIONS IN TRIMMED FORWARD FLIGHT**  
**OH-58D USA S/N 69-16285**

- NOTES: 1. SCAS ON  
 2. EXTENDED STABILIZER INSTALLED  
 3. ZERO SIDESLIP

13. The control positions of the OH-58D in trimmed flight were evaluated in level flight at the conditions shown in table 1. Test results conducted with the extended horizontal stabilizer are presented in figures 5 and 6, appendix E. Increased forward longitudinal control trim positions were required with increased forward airspeeds. Trim control position variations with airspeed showed no discontinuity, and adequate control margins were available. Pitch attitude varied from 1 degree nose up at 40 knots calibrated airspeed (KCAS) to 4 degrees nose down at maximum level flight airspeed. There was a large directional control trim shift (3 inches right) with collective movement between maximum climbing flight and autorotation at 50 KCAS (fig. 7). Additionally, any collective movement required a longitudinal cyclic trim change to maintain pitch attitude and a directional control trim change to maintain ball-centered flight. Control positions of the OH-58D in trimmed forward flight are satisfactory.

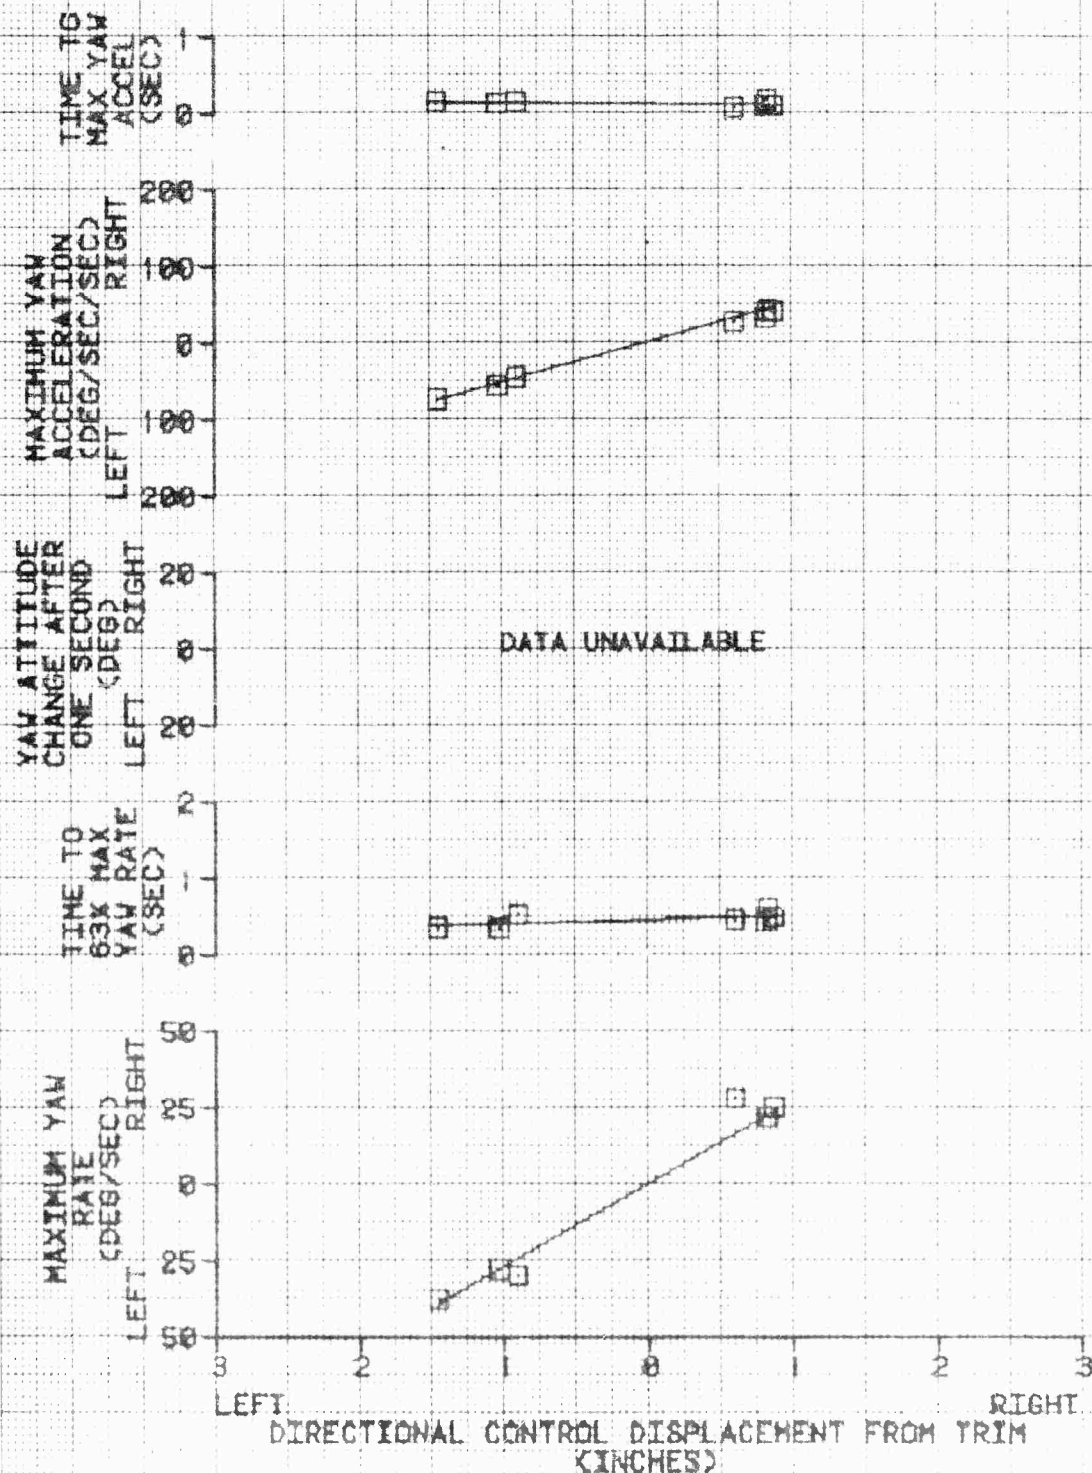
**FIGURE 32**  
**DIRECTIONAL CONTROLLABILITY**  
**OH-58D USA S/N 69-16295**

NOTES: 1. SCAS ON  
 2. SMALL STABILIZER INSTALLED

21. Longitudinal and lateral controllability tests were conducted in hover and in level flight at 102 KCAS in both the primary mission configuration (MMS installed) and in the low drag configuration (MMS removed) at the conditions shown in table 1. Directional control response was also evaluated in a hover in both configurations. Lateral controllability was reevaluated with the extended stabilizer installed and using the new roll SCAS gain changes (reference app B). Data are presented in figures 31 through 42, appendix E.

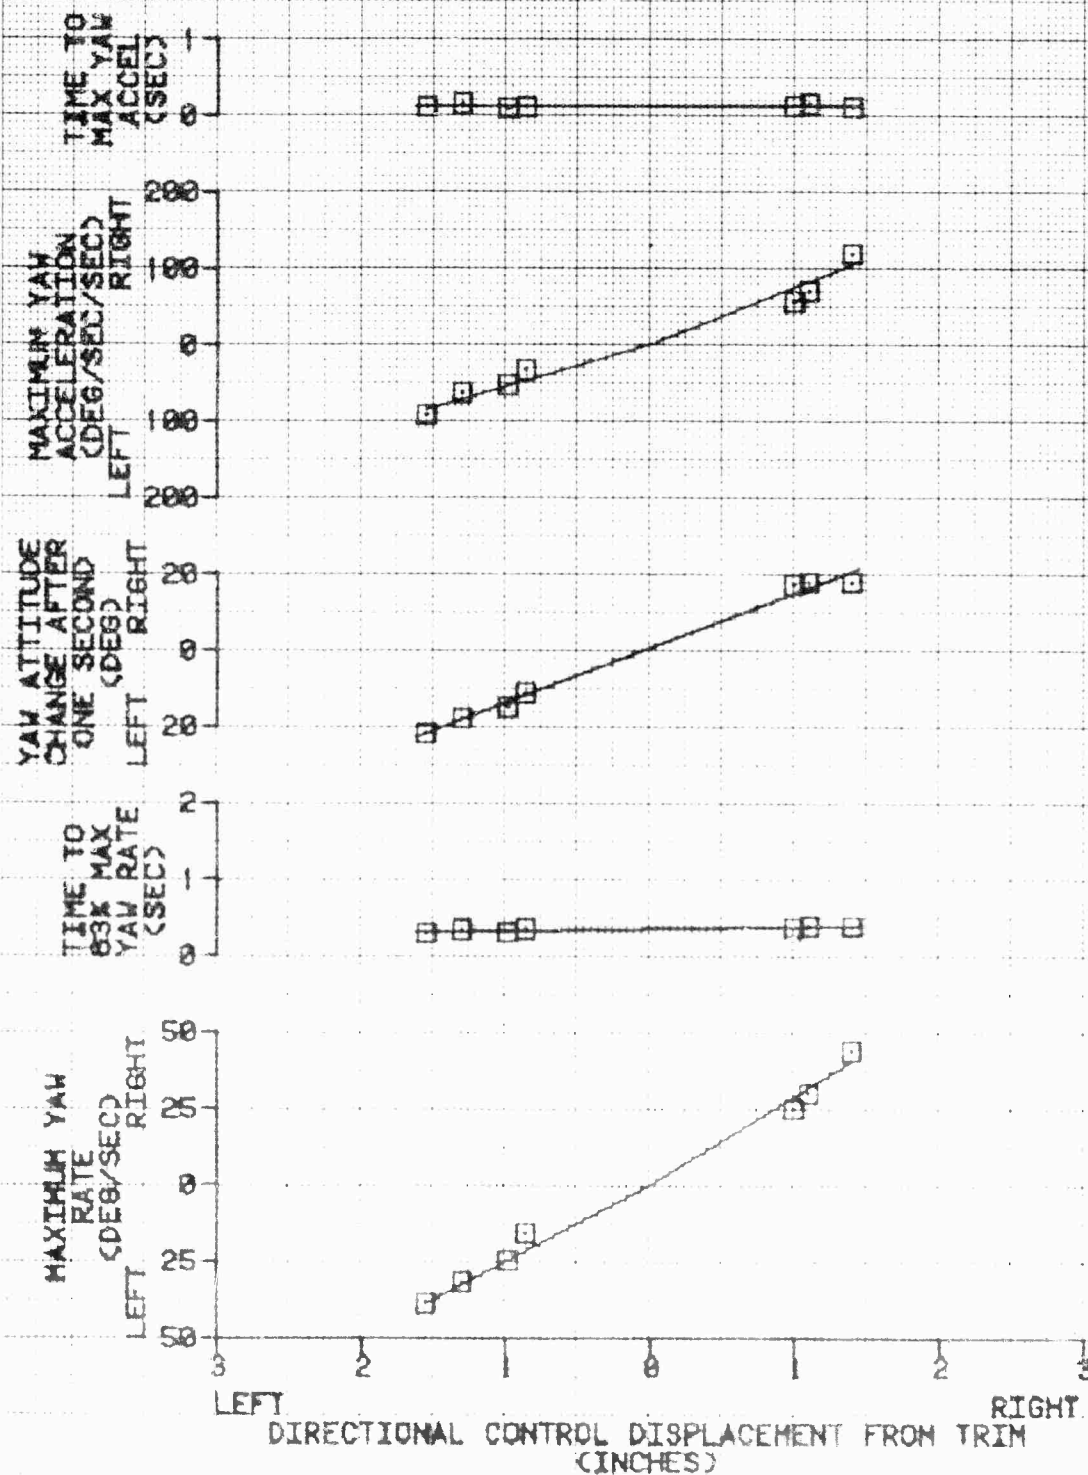
**FIGURE 33**  
**DIRECTIONAL CONTROLLABILITY**  
 OH-58D USA S/N 89-18285

NOTES: 1. SCAS ON  
 2. SMALL STABILIZER INSTALLED

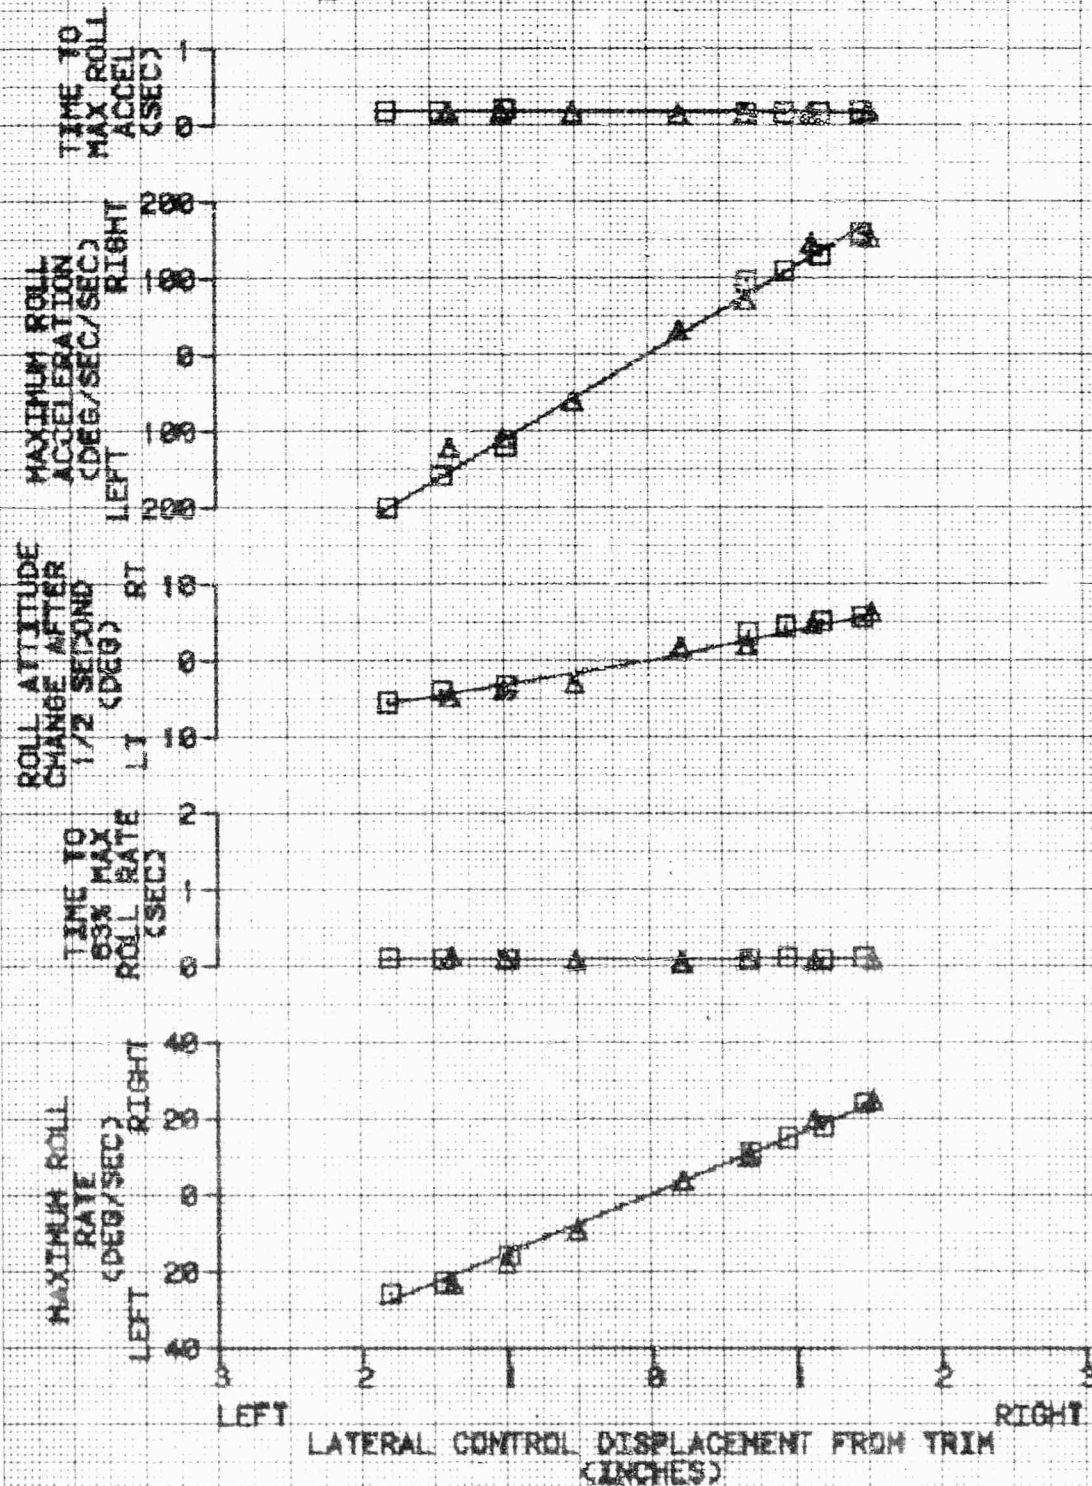
**FIGURE 41**  
**LATERAL CONTROLLABILITY**  
**OH-580 USA S/N 59-10285**

- NOTES:
1. SCAS ON
  2. MAST MOUNTED SIGHT REMOVED
  3. □ DENOTES SMALL STABILIZER AND OLD ROLL SCAS GAINS
  4. △ DENOTES EXTENDED STABILIZER AND NEW ROLL SCAS GAINS

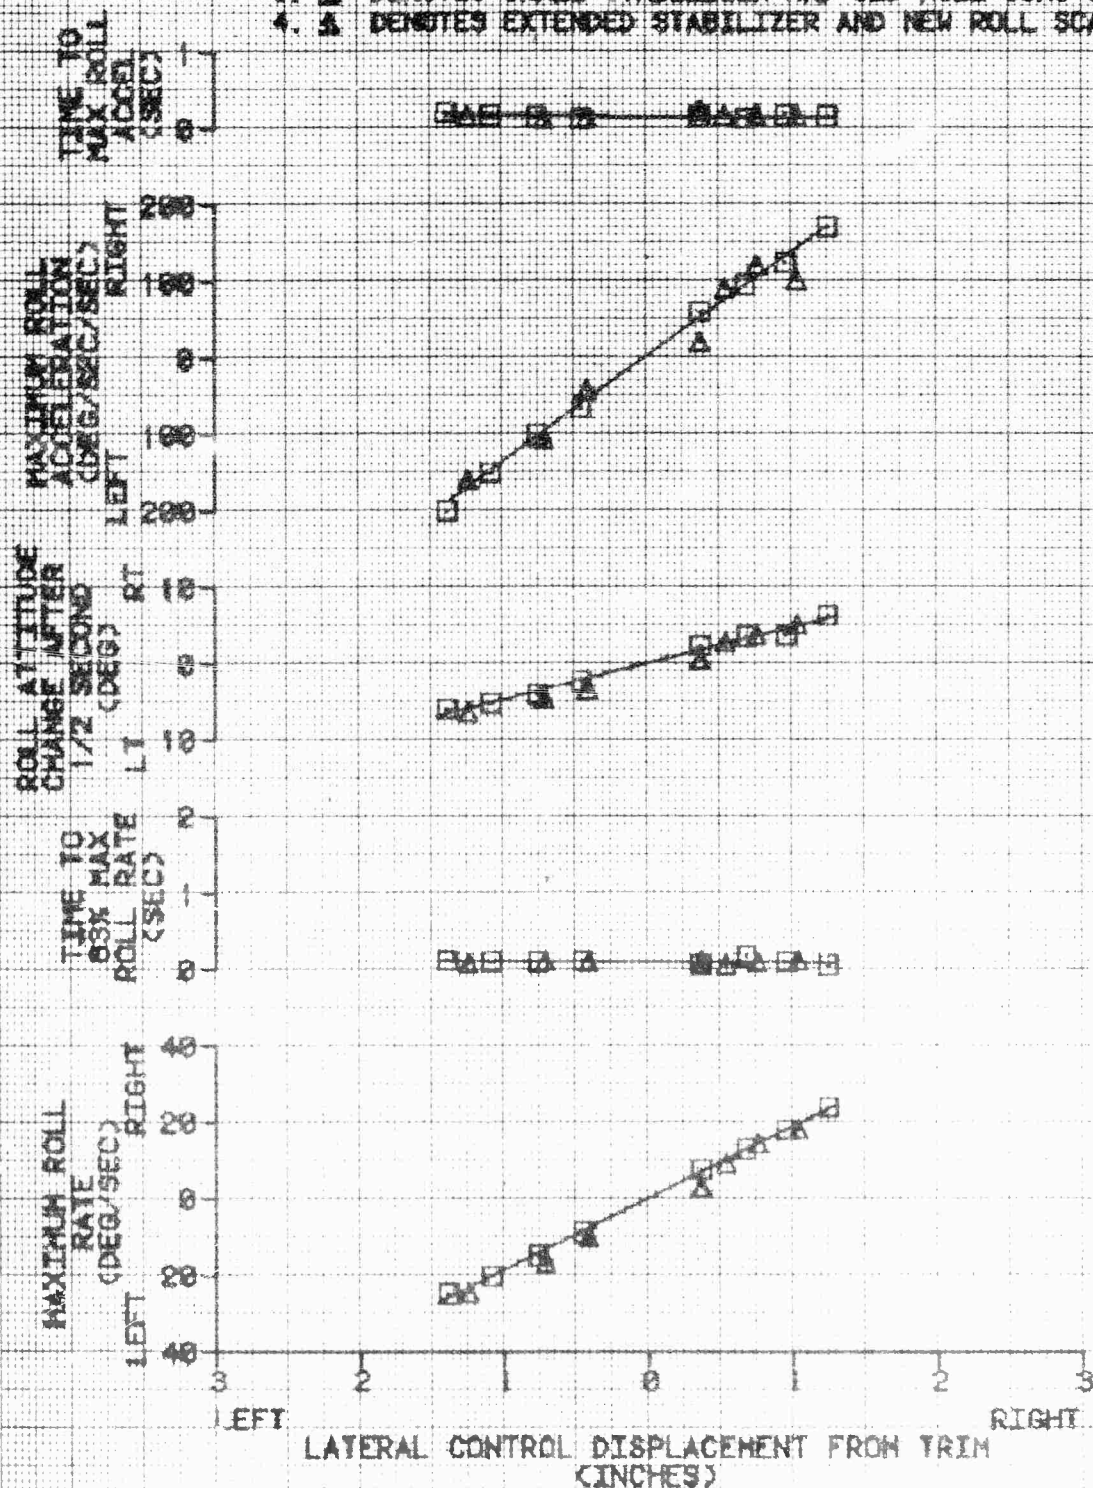
**FIGURE 42**  
**LATERAL CONTROLLABILITY**  
**DH-58D USA S/N 69-16285**

- NOTES: 1. SCAS ON  
 2. □ DENOTES SMALL STABILIZER AND OLD ROLL SCAS GAINS  
 3. △ DENOTES EXTENDED STABILIZER AND NEW ROLL SCAS GAINS

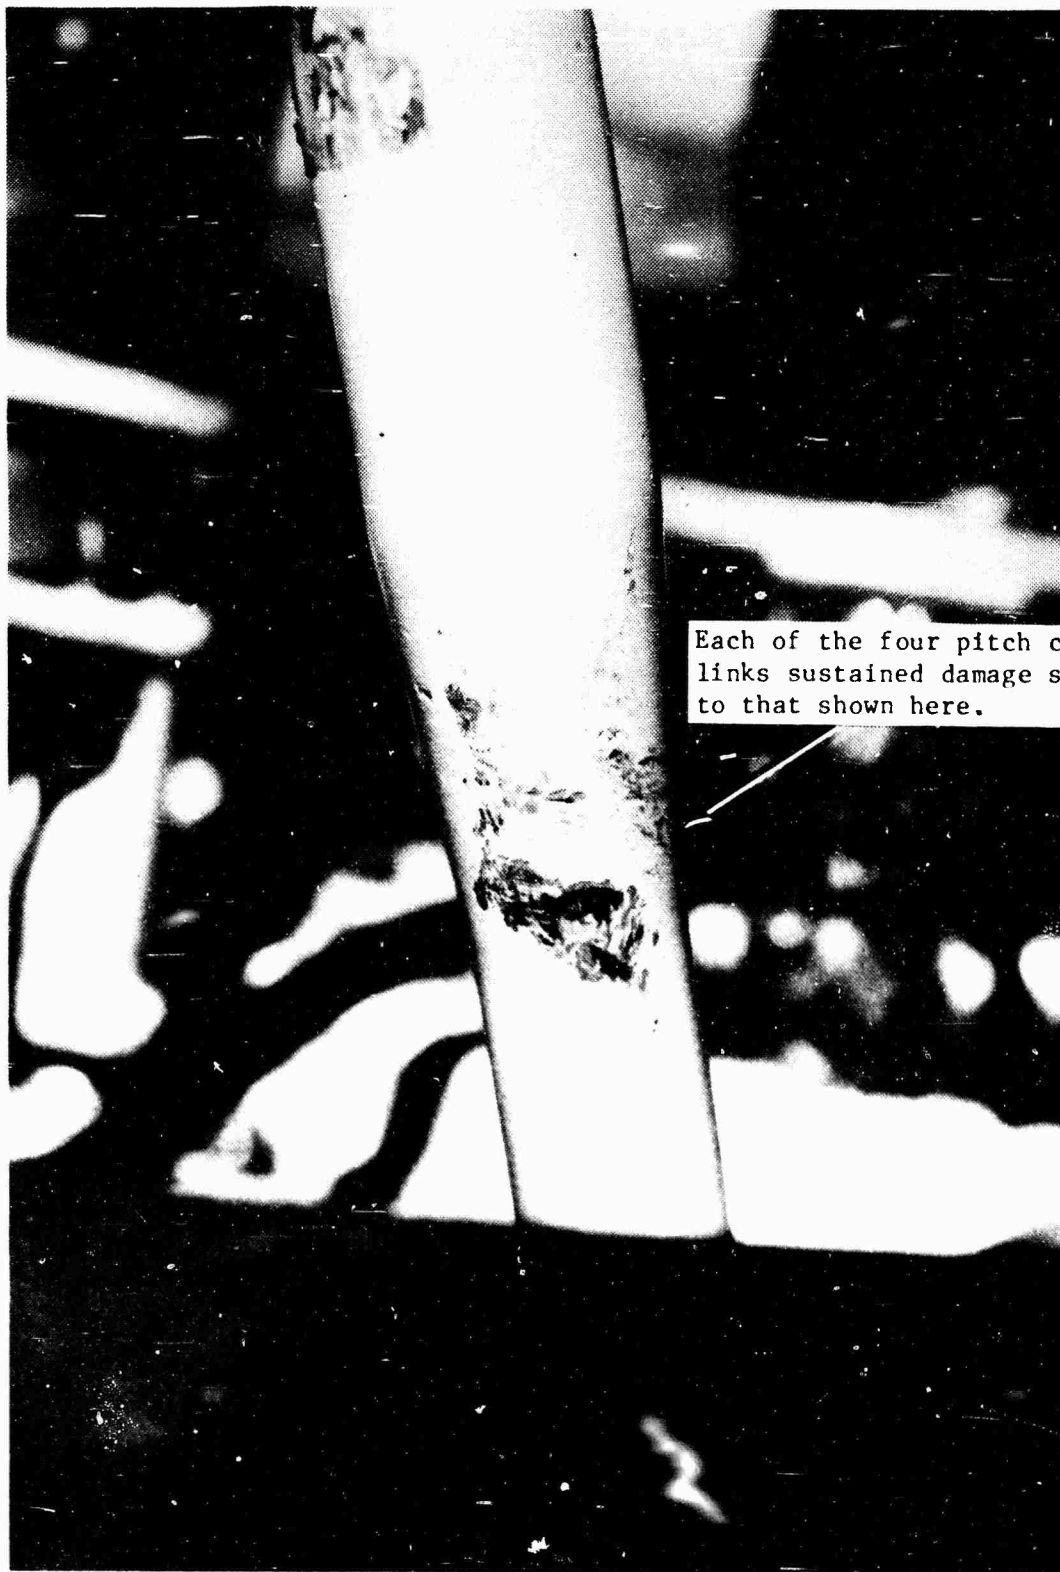
Each of the four pitch change links sustained damage similar to that shown here.
